DELET-TR-80-16

RELIABILITY EVALUATION OF PLASTIC ENCAPSULATED HYBRID
MICROCIRCUITS DEVELOPED FOR ARMY FUZE APPLICATIONS

Edward B. Hakim
John Erickson
ELECTRONICS TECHNOLOGY & DEVICES LABORATORY

August 1980

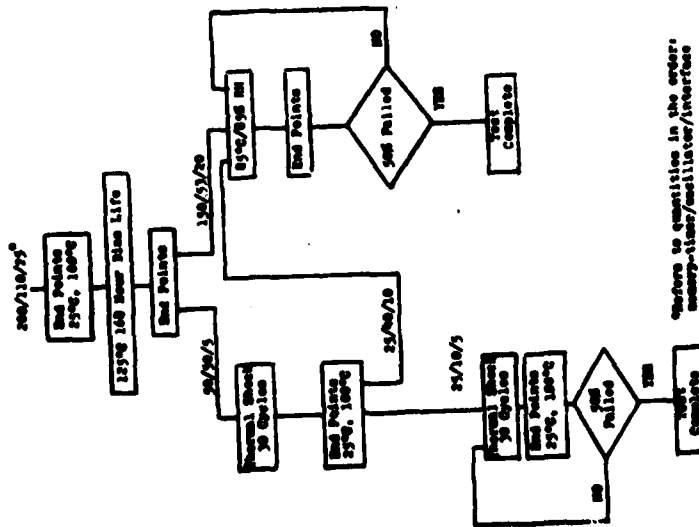
Figure 1. Test Program Flow Chart

The test program is outlined in the Flow Chart, Figure 1. Device quantities were dictated by availability of MM&T Pilot Line units.

The tests were conducted as outlined in the flow chart in Figure 1. Measurements made at 20°C were repeated at 100°C for the initial end point tests and for end point tests for thermal shock. Testing was conducted and is described in the following sections. The failure criterion was no fuze timer circuit output at either 25°C or 100°C. Functional testing began one hour after removal from test and was completed within four hours.

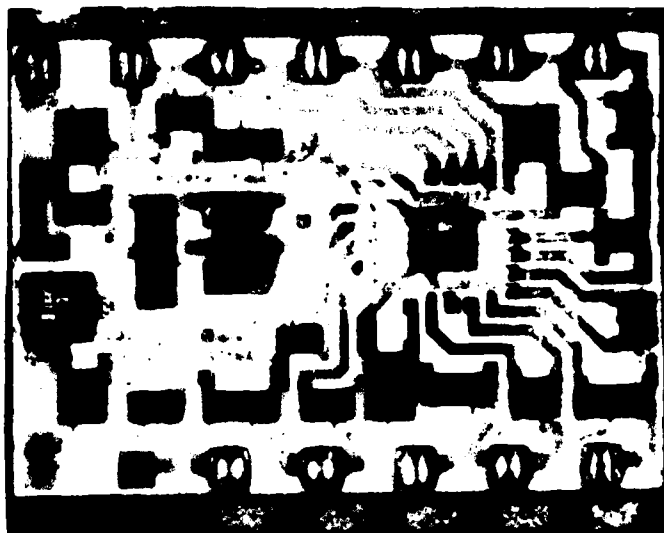
Figure 4. Interface Hybrid Microcircuit Substrate

b. Interface Hybrid Microcircuit - Figure 4 shows the substrate layout of the interface hybrid. Assembly features are:

(1) The custom monolithic integrated circuit (IC) chip. Aluminum metalization is used at bonding pads and interconnects. Ball bonded gold wires are used from chip to substrate. There is no passivation over the metalization. The die attachment to the substrate is accomplished using silver-loaded epoxy.

(2) A silicon controlled rectifier (SCR) chip. Die attach using gold-silicon eutectic bonding.

(3) Bonding of leads to substrate is performed using a solder paste and solder reflow. The package is an oversized 14 lead dual in-line configuration, 1.410 cm x 2.172 cm (0.555 in x 0.855 in).

(4) Jumper wires on substrate. Four gold wires are used to connect various substrate conductors.

(5) Encapsulation technique. Hysol Epoxy ES4228 is used as a coating over the IC and SCR chips and the four jumper wires prior to package molding with Dow Corning 307 silicone encapsulant.

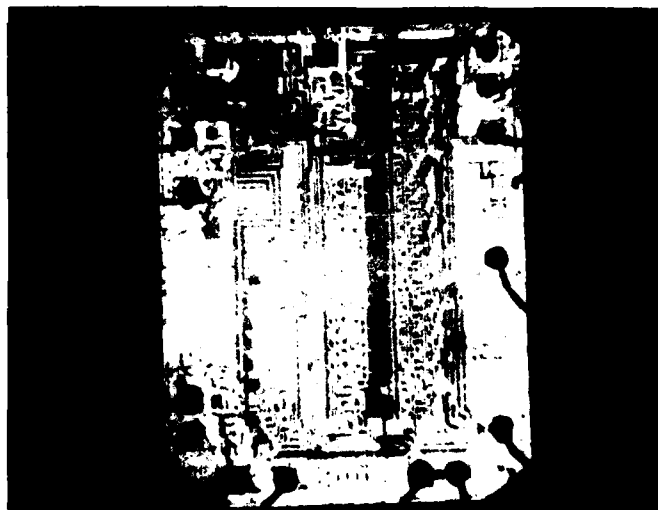
Figure 5. Memory/Timer MNOS Monolithic Chip

c. Memory/Timer - This is an MNOS monolithic microcircuit, with a chip measurement of 0.249 x 0.191 cm (0.098 x 0.075 in), which is packaged in a 16 pin dual in-line plastic package. The encapsulant is Allied 2929B epoxy novalac. The lead frame consists of alloy-42, with selectively gold plated wirebond areas and solder dipped leads. The chip has aluminum interconnect metalization and bonding pads, plasma deposited silicon nitride passivation, eutectic die bonding and thermal compression gold wire bonds. A photo-micrograph of the chip is shown in Figure 5.

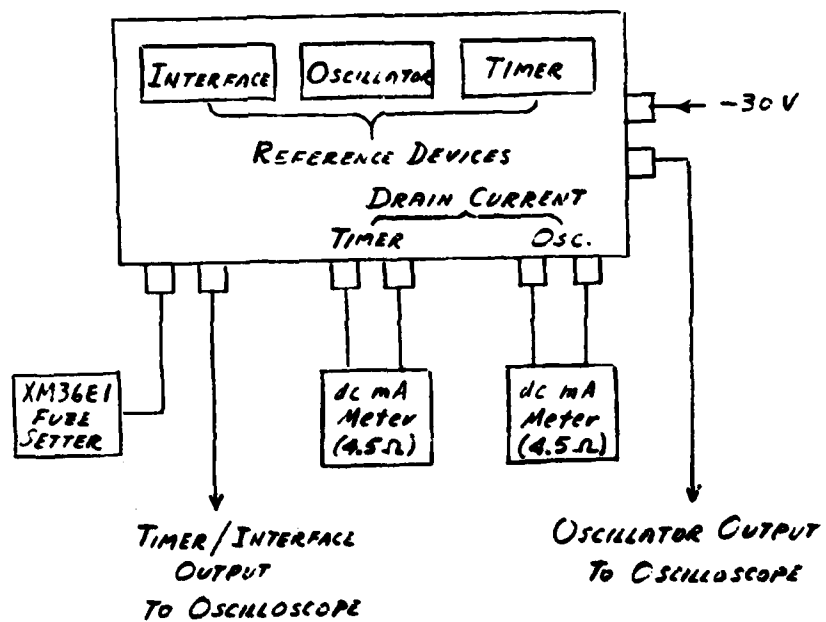
Figure 6. End Point Measurement Test Circuit

The end point measurement test circuit is shown in Figure 6. A "Static-Safe" work station was developed for handling the MNOS timer. The work surface was covered with conductive foil and grounded. Test personnel at the work station were equipped with a wrist band in direct contact with the skin and grounded. Figure 7 shows the "Static-Safe" work station including the test fixture which simulates the fuze timer circuit, the XM36E1 Fuze Setter and test meters. The fuze time is manually set using the XM36E1 Fuze Setter and the time is presented by a light emitting diode (LED) display. A catastrophic failure in the fuze timer circuit or setter will cause the display to indicate error, "E". The end point measurement procedure follows:

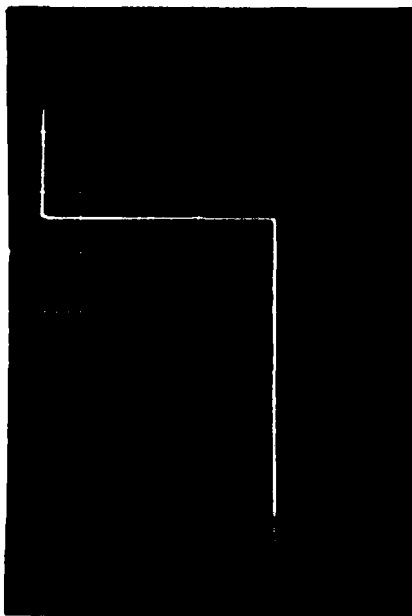
Figure 8. Memory/Timer and Interface Output Waveform (Vert. 5V/div, Horiz. 500ms/div)

Measurements are made at 25°C. The device under test, DUT, is inserted in the test fixture (furnished by Harry Diamond Laboratories). Power is switched "ON" and current drain measured (current drain limits are 2.5 mA minimum and 11 mA maximum). With the power "OFF", fuze setter settings of 178.6 seconds and 4.0 seconds, respectively, are applied to the test fixture. Power is switched "ON" and output waveform observed on an oscilloscope. A typical output waveform is shown in Figure 8. For the thermal shock test, the above measurements are repeated at 100°C.

Measurements are made at 25°C. The DUT is inserted in the test fixture. A fuze setter setting of 4.0 seconds is applied to the test fixture. Power is switched "ON" and output waveform observed on an oscilloscope. The required output waveform is the same as for the memory/timer. For the thermal shock test, the above measurements are repeated at 100°C.

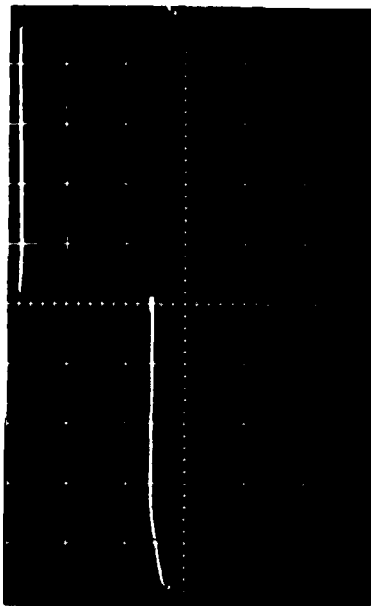
Figure 9. Oscillator Output Waveform (Vert. 5V/div, Horiz. 10μs/div)

Measurements are made at 25°C. The DUT is inserted in the test fixture. Power is switched "ON" and average current drain measured (current drain limit is 2.7 mA maximum). The output duty cycle and period are measured using an oscilloscope (duty cycle limits are 45 to 50% and period limits are 96 microseconds minimum and 107 microseconds maximum). If the period is marginal, a more precise measurement is made using a HP 5304A Timer/Counter. Typical output waveform is shown in Figure 9. For the thermal shock test, the above measurements are repeated at 100°C.

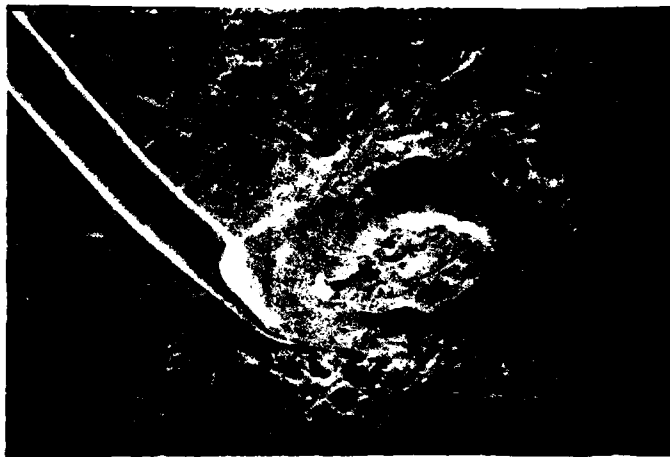
Figure 16. Typical Interface Wire Bonds

A major deficiency with the interface hybrid has been poor quality control, particularly regarding wire bonds. Figure 16 illustrates three different substrate conductor wire bonds. Figure 16a is a 390X SEM photomicrograph of a typical substrate wire bond. Overpressure by the bonding tool has completely flattened the ball and induced neckdown of the wire. Figures 16b and 16c show the same type of bond (130X magnification). This time, only part of the flattened bond exists because of the poor placement of the bond on the conductor. These problems could have been eliminated by precap visual inspection.

- a. Major changes in the assembly of the interface hybrid are required. Changes required include: improvement in wire bonding procedure; elimination of four jumper wires; use of standard lead frame assembly; use of accepted molding procedure and materials.

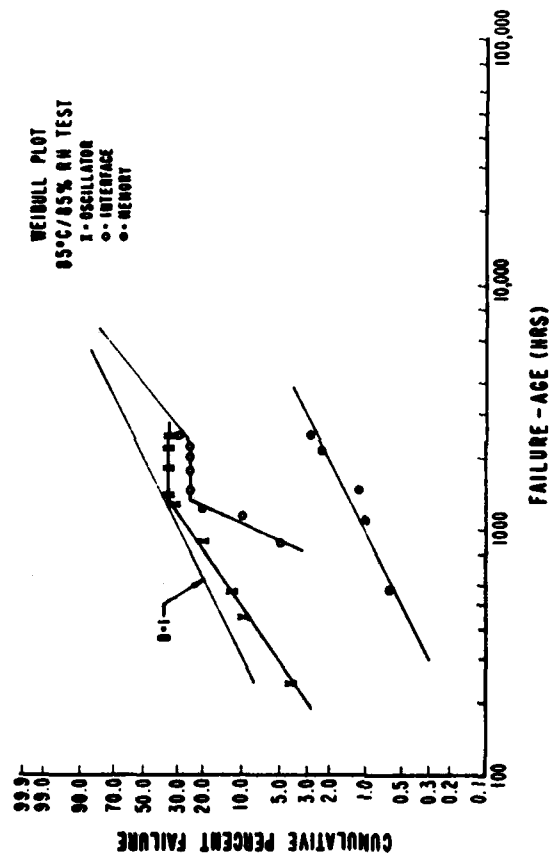
Figure 18. Weibull Humidity Plot

The completed environmental testing and failure analysis does not indicate a plastic encapsulation related reliability problem. Results for the memory/timer monolithic microcircuit indicate excellent performance on both the thermal shock and 85°C/85% RH tests. The median life of the memory/timer device at the accelerated 85°C/85% RH test condition is predicted to be 100,000 hours using a Weibull probability plot, Figure 18.
